A Decaying Confidence

The ill-defined benefits of pressure treated wood

By Gary van Bolderen

October 2021

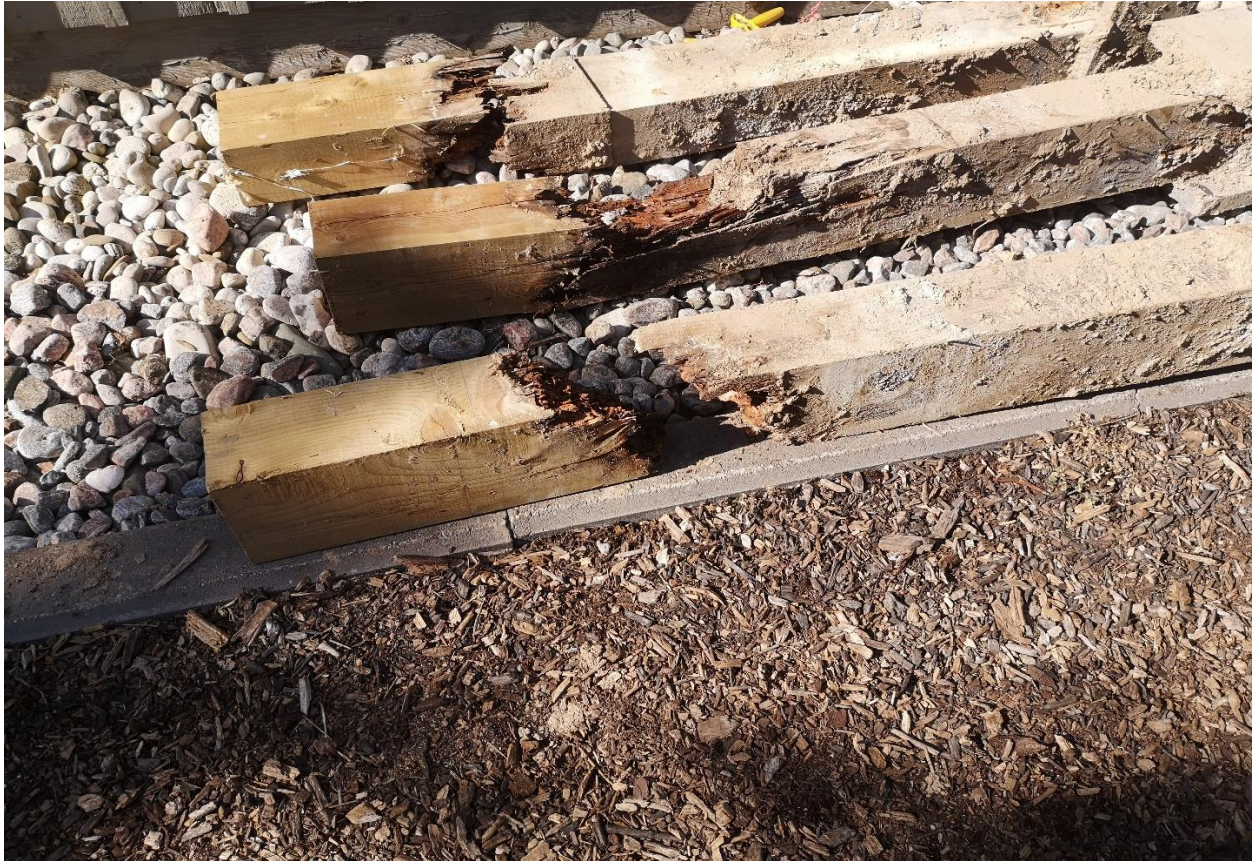
This summer, (July 2021), one of our clients called to ask about two windows being jammed which could not be opened or closed correctly. Upon inspection it was observed that approx. 24’ of the building sidewall, near the window location, had settled approx. 2”. This caused the windows frames to be out of square and the windows to jamb. Upon further inspection it was discovered that three of the 6”x8” pressure treated posts, which supported the building roof truss system, of the pole frame building, had rotted completely. Further observations revealed a fourth post had also rotted.. (See the attached photo of the extent of the decay, taken at the site).

The total rot, through the full cross section of the 6”x8” pressure treated post, was a real shock to me. Since working in the farm building construction industry since 1972, and having built literally hundreds of pole barns, *I have never been asked to replace a pressure treated post, until just four months ago. That is over 50 years, without a known failure.* You can imagine my surprise when I saw these decayed posts, which were only 12 years old. I repeat for emphasis, *“Only 12 years. How could that be?”* I am still in disbelief at what I saw in the totally rotted P.T. posts. It would be less surprising if this was observed in a much older building. Twelve years is a very short time. It is so short that I think it would be accurate to describe these as “temporary” buildings, if supporting structural posts only last 12 years.

6"x8" pressure treated posts completely rotted after 12 years. This was part of the sidewall posts of an indoor riding arena located in Caledon, Ontario. Photo was taken July 2021.

The damage to these structural posts was so complete that the owner was advised to not allow any people inside the building, until the posts were replaced. It was deemed to be unsafe for human occupancy. The owner immediately arranged for these posts to be replaced, fearing the collapse of the structure if repairs were not done.
